**Flood Control Project Maintenance  
Levee Inspections  
LMA District Cover Sheet  
Spring 2010 Levee Inspection Results**

**Reclamation District No. 0349 Sutter Island**

**Spring 2010 Levee Inspection Results**

**Levee Inspection Report By Mile - Spring 2010**

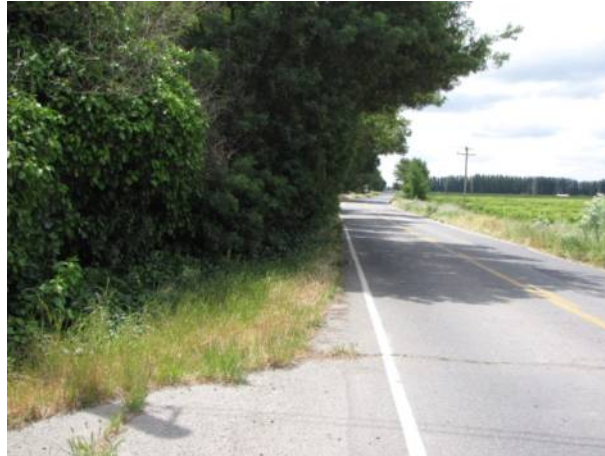
Levee Mile Report Line	1
Start Levee Mile	0.00
End Levee Mile	0.03
Location	Water Side
Category	Earthen Levee
Item	Encroachments

Photo of landscaping at levee mile 0.00- 0.03 waterward.

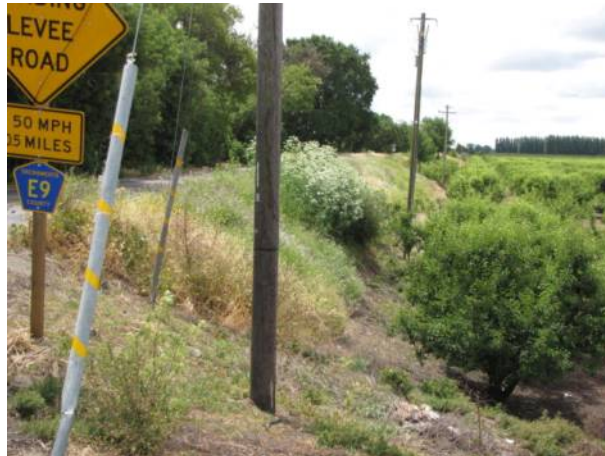
Levee Mile Report Line	3
Start Levee Mile	0.17
End Levee Mile	0.70
Location	Land Side
Category	Earthen Levee
Item	Vegetation

Standing on landside at L/M 0.00 Unit 1 looking down stream at slope. Here the weeds are taller than 12". Farther down stream the weeds are taller. 38.327032 -121.577093

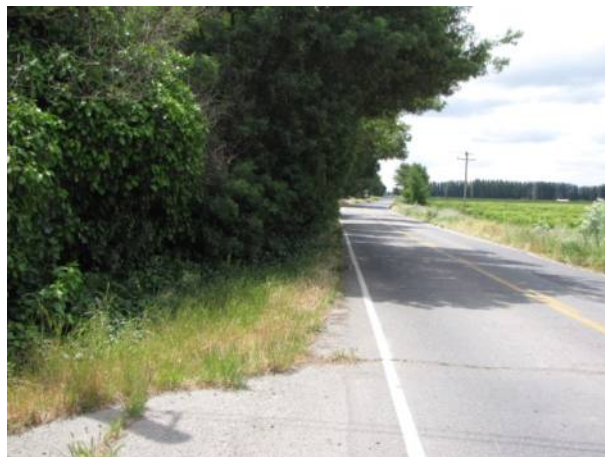
Levee Mile Report Line	3
Start Levee Mile	0.17
End Levee Mile	0.70
Location	Land Side
Category	Earthen Levee
Item	Vegetation

Standing on water side at L/M 0.00 the water side slope at this location is taken over by growth. Looking downstream.

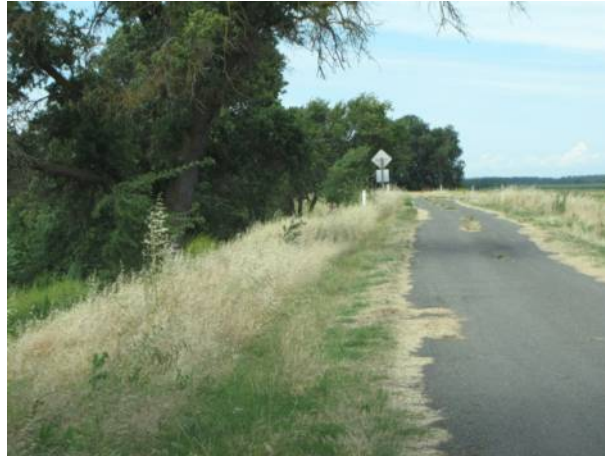
Levee Mile Report Line	1
Start Levee Mile	0.03
End Levee Mile	0.07
Location	Water Side
Category	Earthen Levee
Item	Vegetation

This picture shows the growth on waterward slope. This growth is present through the Unit. This marks the beginning of unit 2.

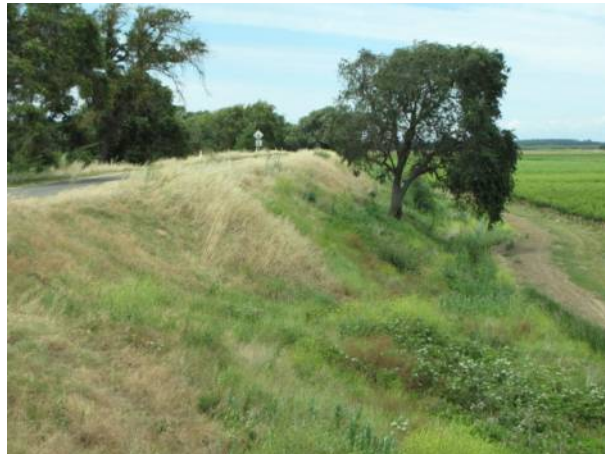
Levee Mile Report Line	2
Start Levee Mile	0.04
End Levee Mile	0.52
Location	Land Side
Category	Earthen Levee
Item	Vegetation

This photo shows growth on levee slopes landward although the weeds here are taller than 12-inches, it does not block visibility of the levee. This growth is consistent through this unit.

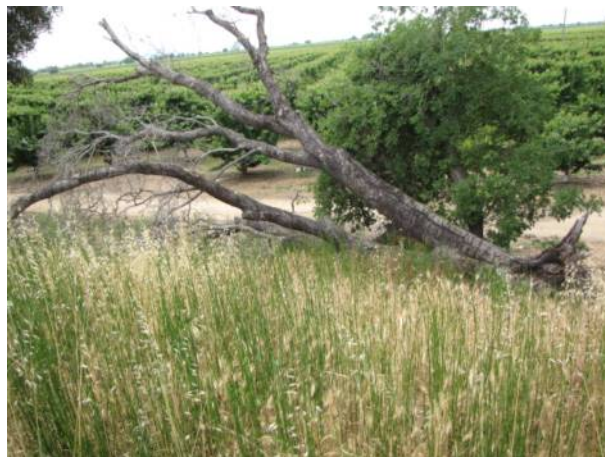
Levee Mile Report Line	17
Start Levee Mile	1.63
End Levee Mile	1.63
Location	Land Side
Category	Earthen Levee
Item	Encroachments

This tree was on the levee slope during my last inspection, the District has been told to remove it, it still remains today. No attempt has been made to remove.

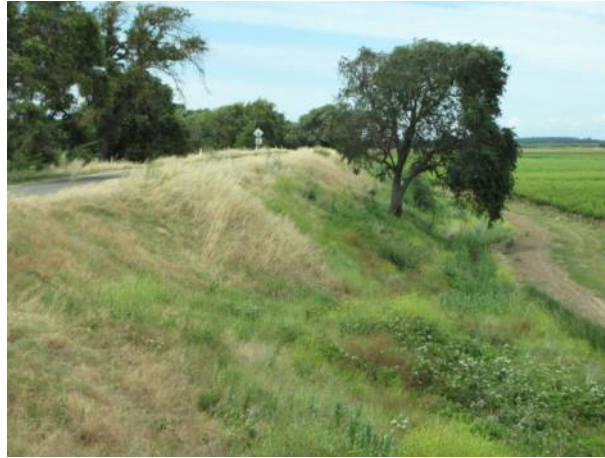
Levee Mile Report Line	1
Start Levee Mile	0.00
End Levee Mile	1.08
Location	Land Side
Category	Earthen Levee
Item	Vegetation

This photo shown here is a sampling of what the land side growth looks like through this unit, however there are some sections where the growth is much taller. Standing here at levee mile 0.00 looking downstream.

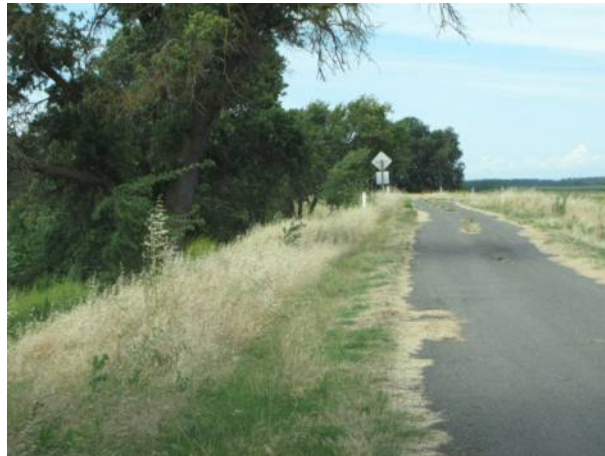
Levee Mile Report Line	2
Start Levee Mile	0.01
End Levee Mile	1.15
Location	Water Side
Category	Earthen Levee
Item	Vegetation

Standing here on the water ward side of the levee at levee mile 0.01 looking down stream, tall weeds are viewed on levee slopes.

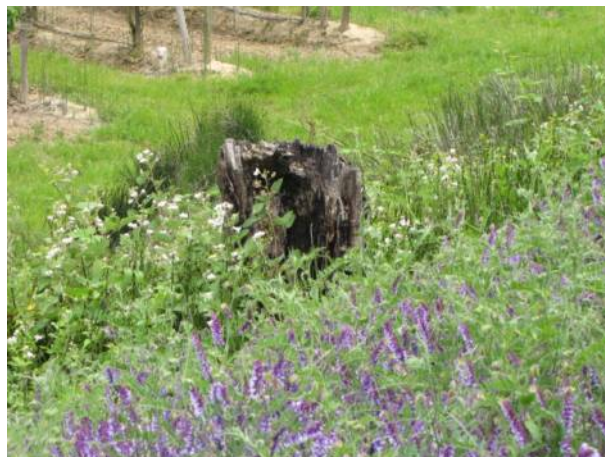
Levee Mile Report Line	3
Start Levee Mile	0.62
End Levee Mile	0.62
Location	Land Side
Category	Earthen Levee
Item	Trim / Thin Trees

This stump is located on the landward slope.

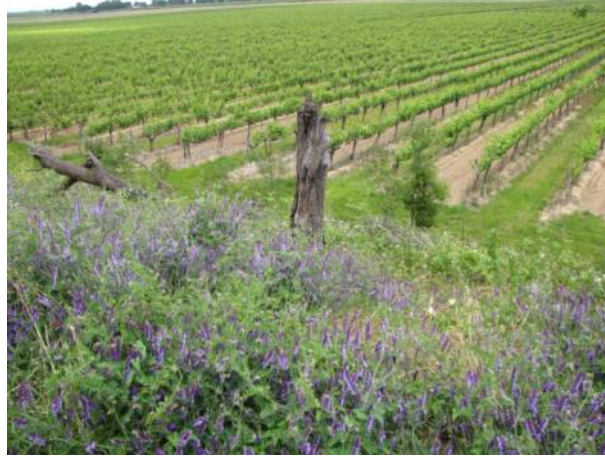
Levee Mile Report Line	4
Start Levee Mile	0.63
End Levee Mile	0.63
Location	Land Side
Category	Earthen Levee
Item	Trim / Thin Trees

Broken tree with stump on landward slope, broken top portion of this tree is resting on the landward toe. District is aware of this encroachment.
